**REPORT TO THE BOARDS OF DIRECTORS OF CRUISE LLC,  
GM CRUISE HOLDINGS LLC, AND GENERAL MOTORS  
HOLDINGS LLC REGARDING THE  
OCTOBER 2, 2023 ACCIDENT IN SAN FRANCISCO**

**January 24, 2024**

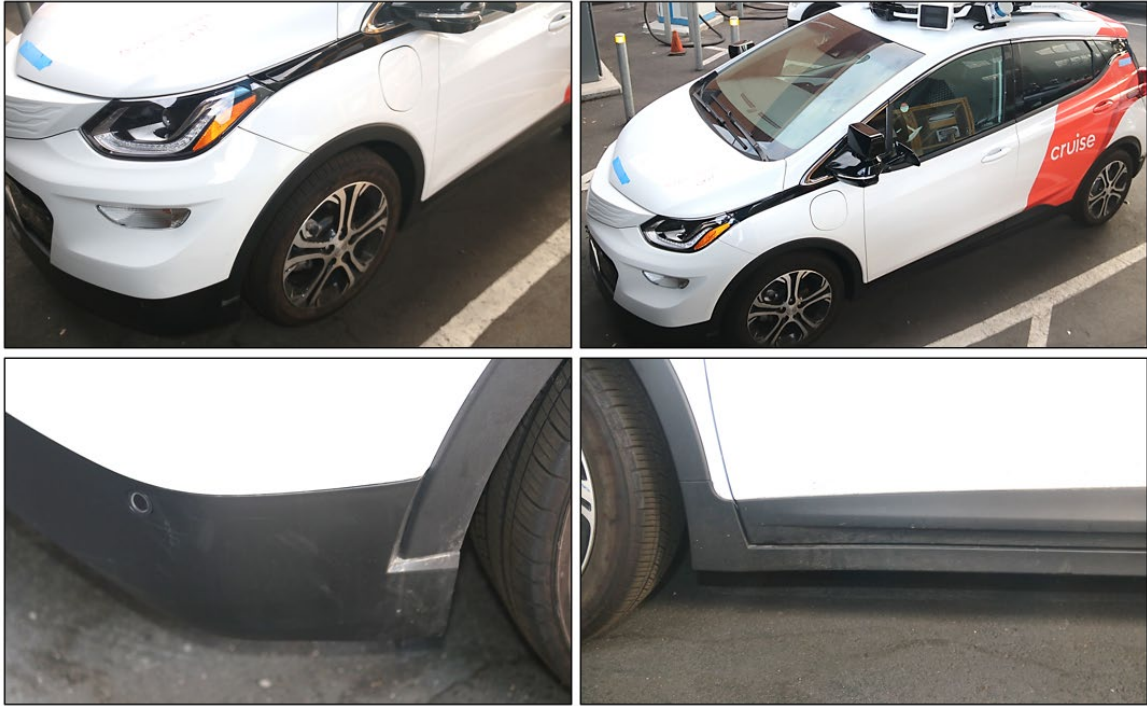
Figure 4. Photographs of the outside of the AV.

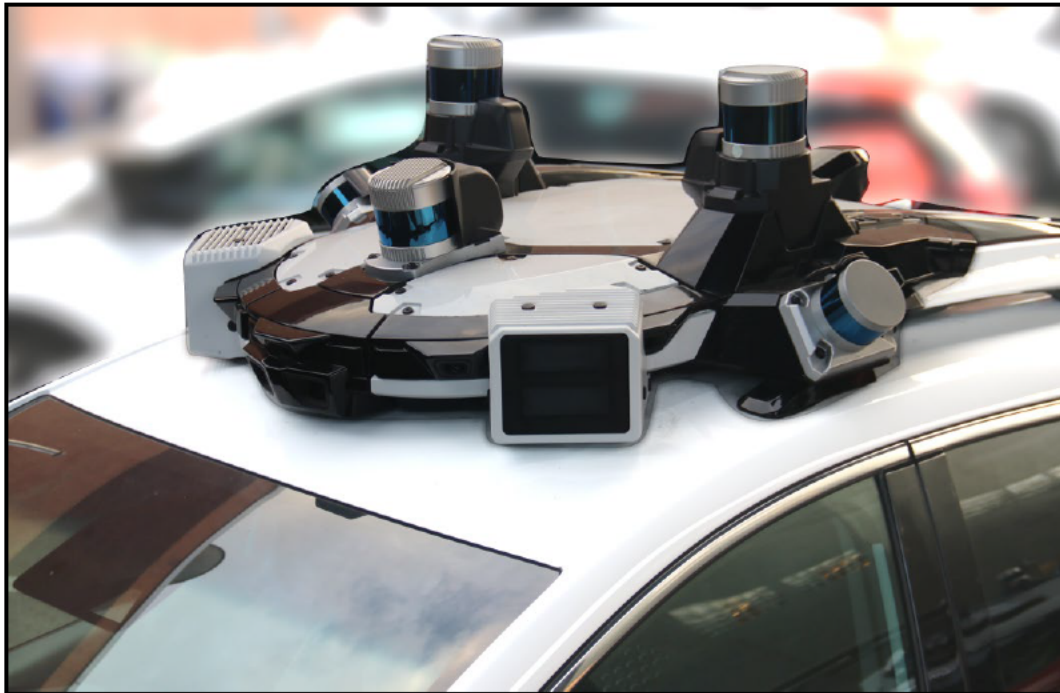
Figure 7. Roof mounted sensor array which includes lidars, cameras, and radars.

[REDACTED] Figure 7 shows some of the externally visible sensors mounted on the roof of the AV.
